APPLICATION OF INFRARED CAMERA FOR MONITORING OF TRANSFORMER BUSHING

¹ Pankaj S. Kamble, ² Dr. Bhoopesh N. Chaudhari

¹Student, ME (EPS), ²Professor

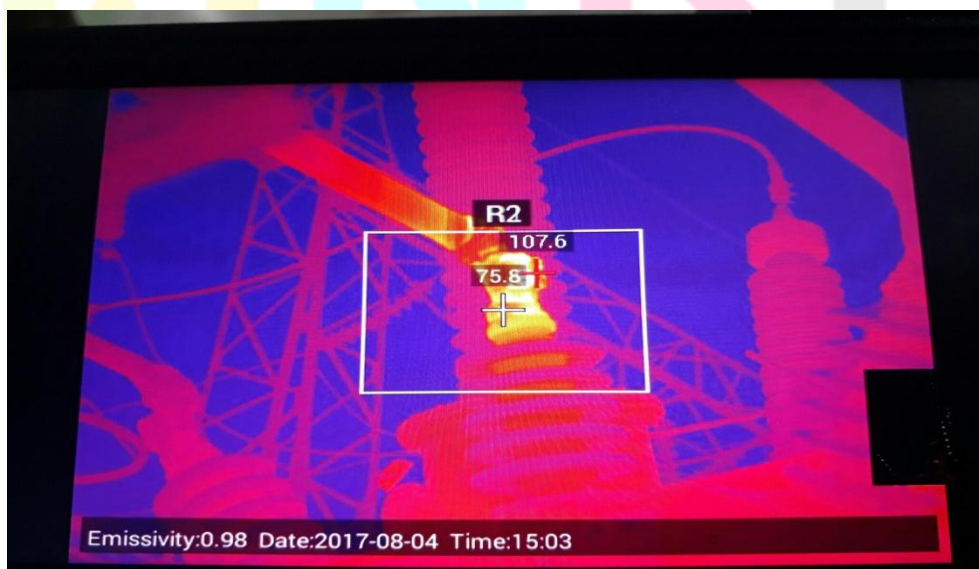
Heat is an important factor in high voltage installations. When electrical current passes through a resistive element, it generates heat. An increased resistance results in an increase in heat. Over time the resistance of electrical connections will increase, due to loosening and corrosion for instance. The corresponding rise in temperature can cause components to fail, resulting in unplanned outages and even injuries. In addition, the energy spent on generating heat causes unnecessary energy losses. If left unchecked, the heat can even rise to the point where connections melt and break down; as a result, fires may break out. By using infrared camera hot spot on Y phase 132kV transformer bushing was identified as shown in figure [2].

Figure 2: Hot spot on 132kV Y phase bushing

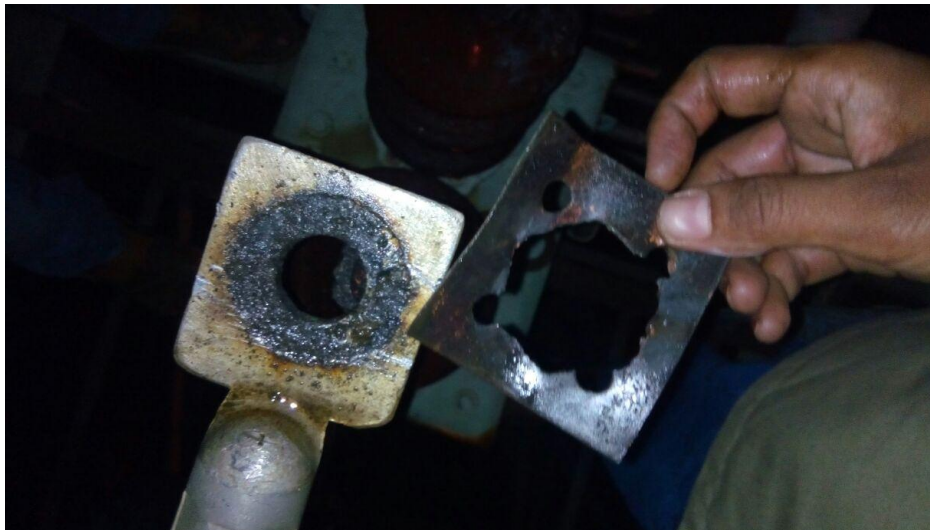
It was found that the due to loosening of conductor contact overheated causing corrosion on connector as shown in figure [3]

Figure 3: overheated connector

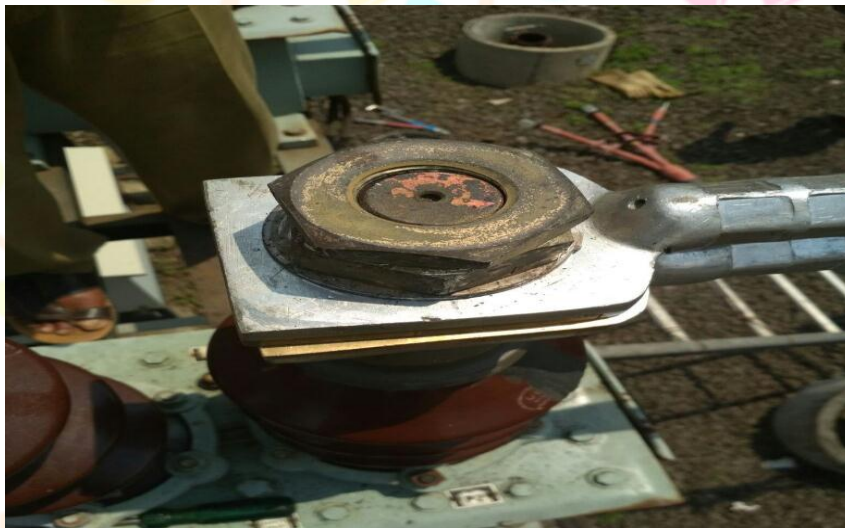
Figure 4: healthy connector

After outage by replacing connector bushing was placed on transformer as shown in figure [4].

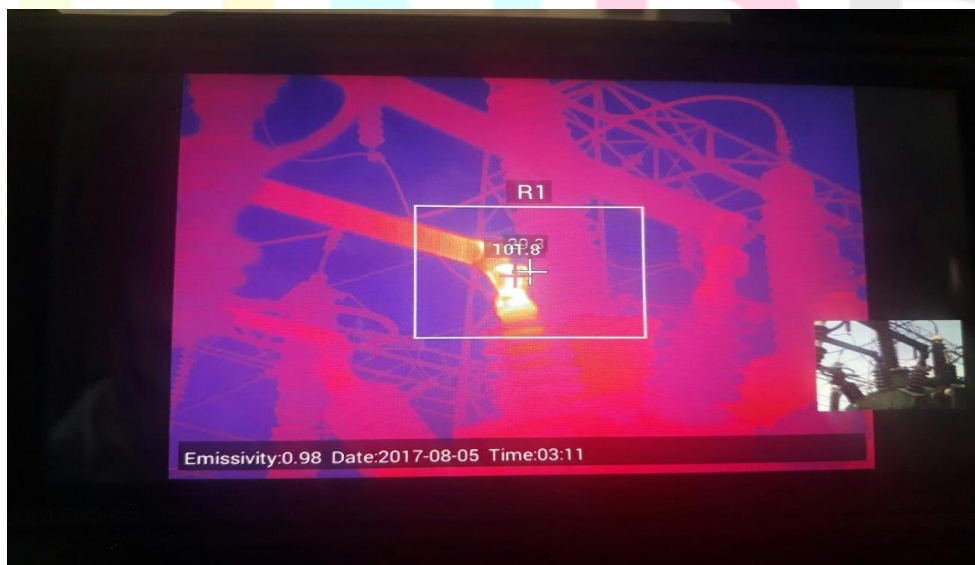
Once again thermal scanning was carried out on bushing showing the hot spot on 132kV Y phase bushing as shown in figure [5]

Figure 5: hot spot detected on Y phase of Bushing

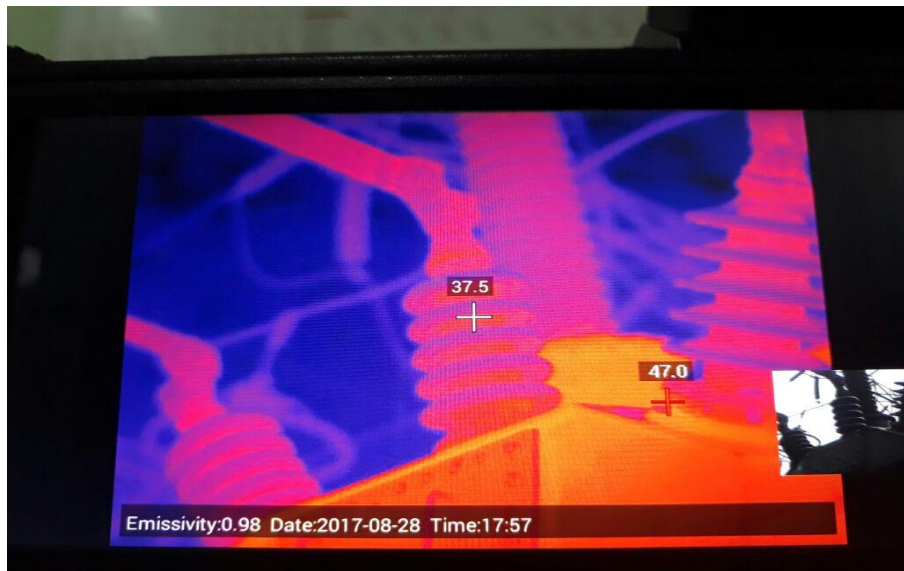
Figure 6: hot spot cleared on Y phase Bushing

After outage it was observed that internal bushing rod was damaged due to overheating. So bushing was replaced by healthy one on Y phase 123kV transformer. Thermal scan showing healthy functioning of Y phase bushing as shown in figure [4].
